Impact of a rock avalanche on a moraine-dammed proglacial lake: Laguna Safuna Alta, Cordillera Blanca, Peru

Abstract

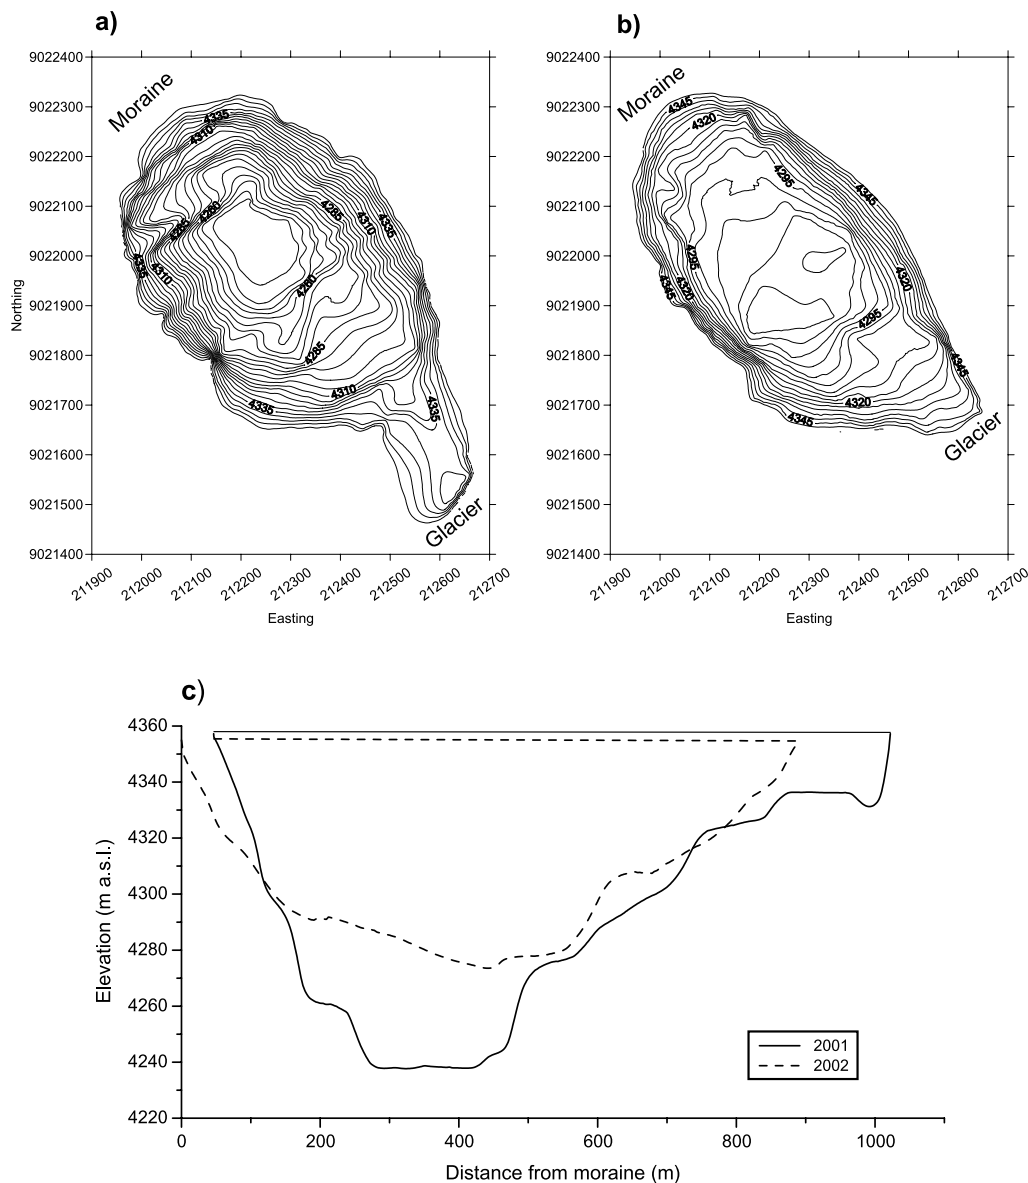
Figure 2. Bathymetric maps (contour interval of 5 m) of Laguna Safuna Alta (a) in 2001 (prior to the avalanche) and (b) in 2002 (following the avalanche), and (c) long sections through the two basins. The planform location of this long section is marked in Figure 5.

Figure 2(a) and in centerline long section in Figure 2(c)) revealed that the lake's maximum depth was reduced from ~120 m in 2001 to ~81 m in 2002. The location of the deepest point has also shifted towards the south-east, the deepest point in 2001 having been reduced in depth by almost 50 m. These patterns of change may be visualized by superimposing the 2002 lake outline onto the 2001 lake outline and contouring the difference in bathymetry between the two, calculated as elevation in 2002 minus elevation in 2001 (Figure 5). As anticipated, most of the basin has been filled in, with the greatest amount of accretion occurring in the deepest part of the pre-avalanche basin. In addition, the south-eastern section of the lake where it abutted the glacier has been filled in completely by avalanche material, reducing the lake's surface area by ~150 m × 200 m (marked **A** in Figure 5). Material has also been deposited along both lateral moraines of the basin, effectively reducing the lake's width by between 50 and 100 m along most of its length (marked **B** in Figure 5). Given the location of this material, it is likely that much of it was derived from erosion

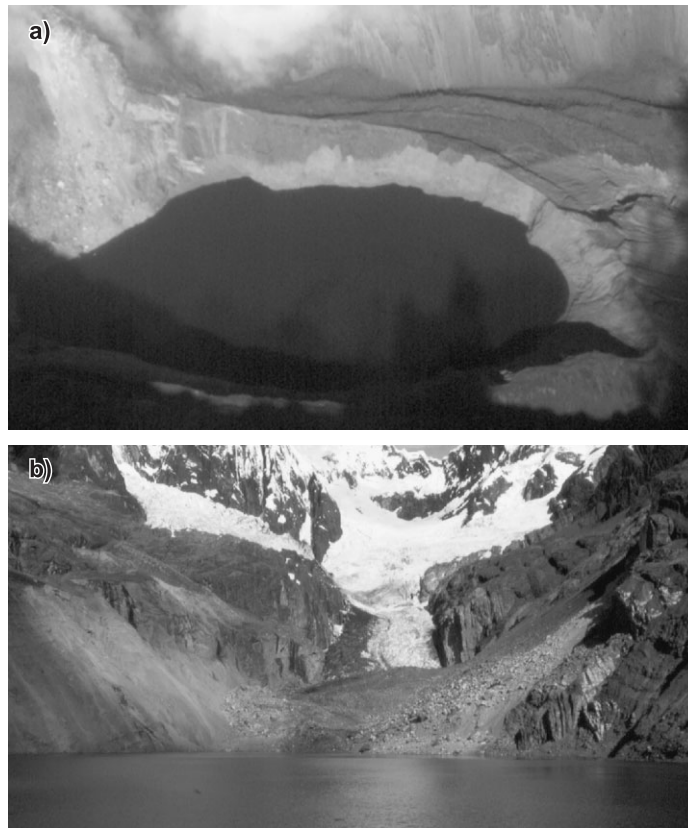
In August 2002, the avalanche scar and rock deposits were clearly visible from the air (Figure 3(a)), as was extensive fresh erosion of the surface of the impounding moraine dam. Exposed rock slopes in the area of the avalanche scar consist largely of quartzite with sub-vertical foliation that strikes parallel to the long axis of the valley (approximately 145°). Extensive tension cracking was observed in a zone between 100 and 150 m wide located to the rear of the crest of the slip and to the north of the centre of the slip, at an altitude close to 4700 m a.s.l. These cracks ranged in width from 75 mm to 2 m and were observed to a depth of >6 m (Figure 4). A major back scarp, with a throw of 5–6 m, is located at an altitude close to 4720 m a.s.l. in the north, rising to 4745 m a.s.l. in the centre of the existing slip zone. This scarp marks the rear of the highly disturbed area, although some smaller subsidiary tension cracks are visible to the rear of this feature up to an altitude of around 4800 m a.s.l.

Avalanche debris that fell onto the glacier tongue forms a deposit that crosses and obscures the full width of the ice surface (Figure 3(b)). The dimensions of this deposit were estimated to be 300–400 m along-glacier, 200 m across-glacier, and up to 40–50 m thick. These dimensions equate to a debris volume of $2\text{--}4 \times 10^6 \text{ m}^3$, or, assuming a bulking factor of 1.5 (i.e. host rock has a density of 1.5 times that of the unconsolidated debris deposited on the glacier surface), ~10–30% of the volume of rock estimated to have been delivered from the avalanche scar (equating to a mass of $\sim 4\text{--}7 \times 10^9 \text{ kg}$). Investigation of the northern (i.e. lake-ward) slopes of the landslide debris revealed the presence of numerous linear, shore-parallel features, defined by stranded vegetation and back scarps.

Figure 3. Photographs of (a) the avalanche scar and associated erosion viewed from the air, and (b) the avalanche deposit on the surface of Glaciar Pucajirca and in the southern end of Laguna Safuna Alta.

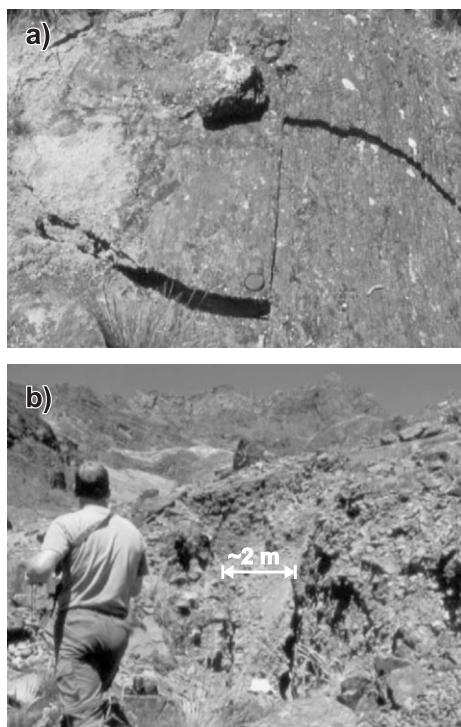
Figure 4. Photographs of (a) small (note lens cap for scale) and (b) large tension cracks in the terrain above and to the north of the existing avalanche scar immediately to the south-west of Laguna Safuna Alta.

Inspection of the slope adjacent to the rockfall of 22 April 2002 revealed a large number of active back scarps and tension cracks. Rock strata at the toe of the northern end of the landslide are generally sub-vertical, but become severely overhanging higher up this exposure and towards the back scarp of the landslide itself. There can be little doubt that the potential exists for another large-scale failure. The extent of the fractured area is perhaps half as extensive as that affected by the rock avalanche of 22 April 2002, potentially resulting in an avalanche of volume of $\sim 5 \times 10^6 \text{ m}^3$, yielding $\sim 13 \times 10^9 \text{ kg}$ of rock. Given the location of the unstable ground in relation to the tongue of Glacier Pucajirca, it is likely that a high proportion of any future rock avalanche material would fall directly into the lake.

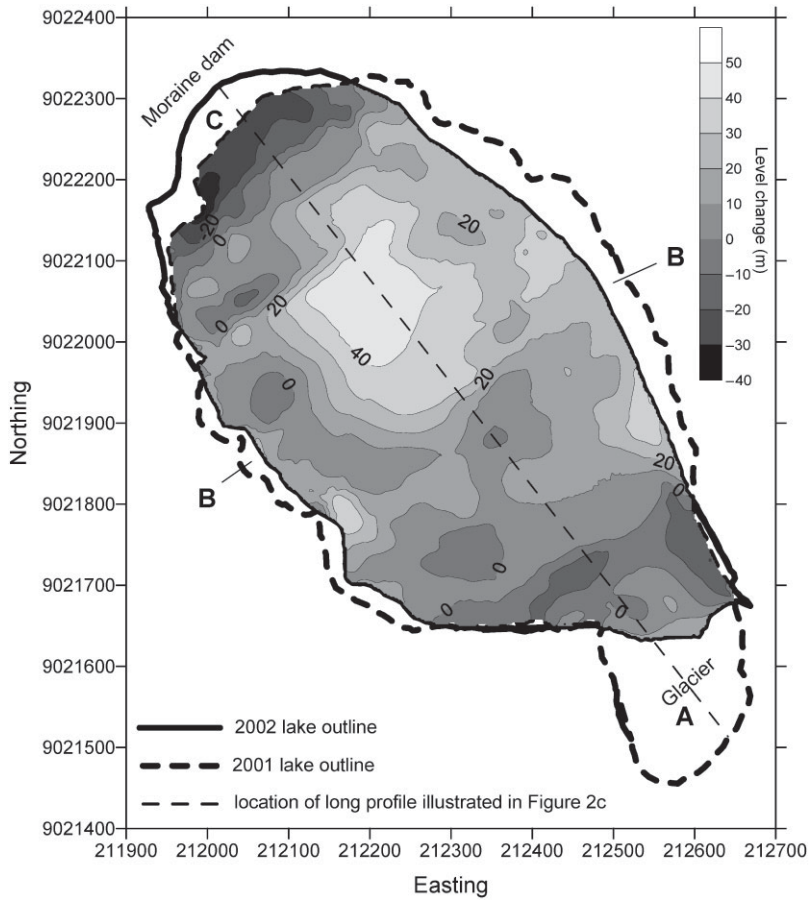
higher up the basin's lateral moraine flanks rather than from the avalanche. Finally, it is worth noting that the lake surface has extended its northern margin by eroding into the terminal moraine dam wall by up to ~40 m (marked C in Figure 5).

Figure 5. Surface outlines of Laguna Safuna Alta in 2001 (prior to the avalanche) and 2002 (following the avalanche) and a contour plot of the change in basin elevation in overlapping areas. Descriptions of the areas marked A, B and C are provided in the text. The dashed line indicates the location of the profile illustrated in Figure 2(c).

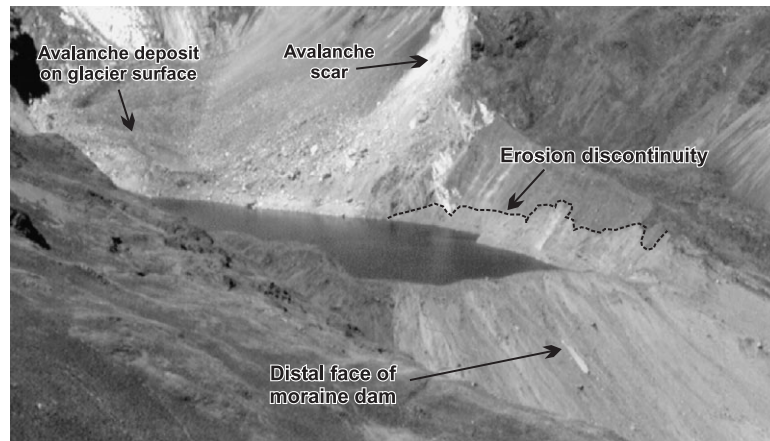
walls of the lake basin, away from the southern end of the lake, where the landslide entered the water (Figure 6). This rise in elevation continues until the lighter zone intersects the crest of the moraine near the northern end of the lake. Close inspection within the lighter zone of the proximal terminal moraine slope reveals the presence of a series of up to ten linear surface discontinuities. Each of these is marked by a slight ledge, similar to that between the uppermost limit of the lighter zone and the overlying darker zone, consistent with the relative removal of material below each discontinuity. Each of these ledges can be traced for lateral distances of tens to hundreds of metres, often across the entire face of the moraine. Within this zone, the concrete lining of the 1978 relief tunnel (which was flush to the moraine face until 2001) was observed to protrude from the face by ~ 4 m in August 2002.

The light-coloured zones are interpreted to be areas of fresh erosion created by seiche action. This interpretation is discussed in more detail below.

Figure 6. Photograph of Laguna Safuna Alta and its immediate surroundings taken in August 2002. Note the rise in the level of light-coloured surface material (marked as 'erosional discontinuity') along the inner slopes of the lake basin away from the avalanche deposit, also visible in Figure 3(a).

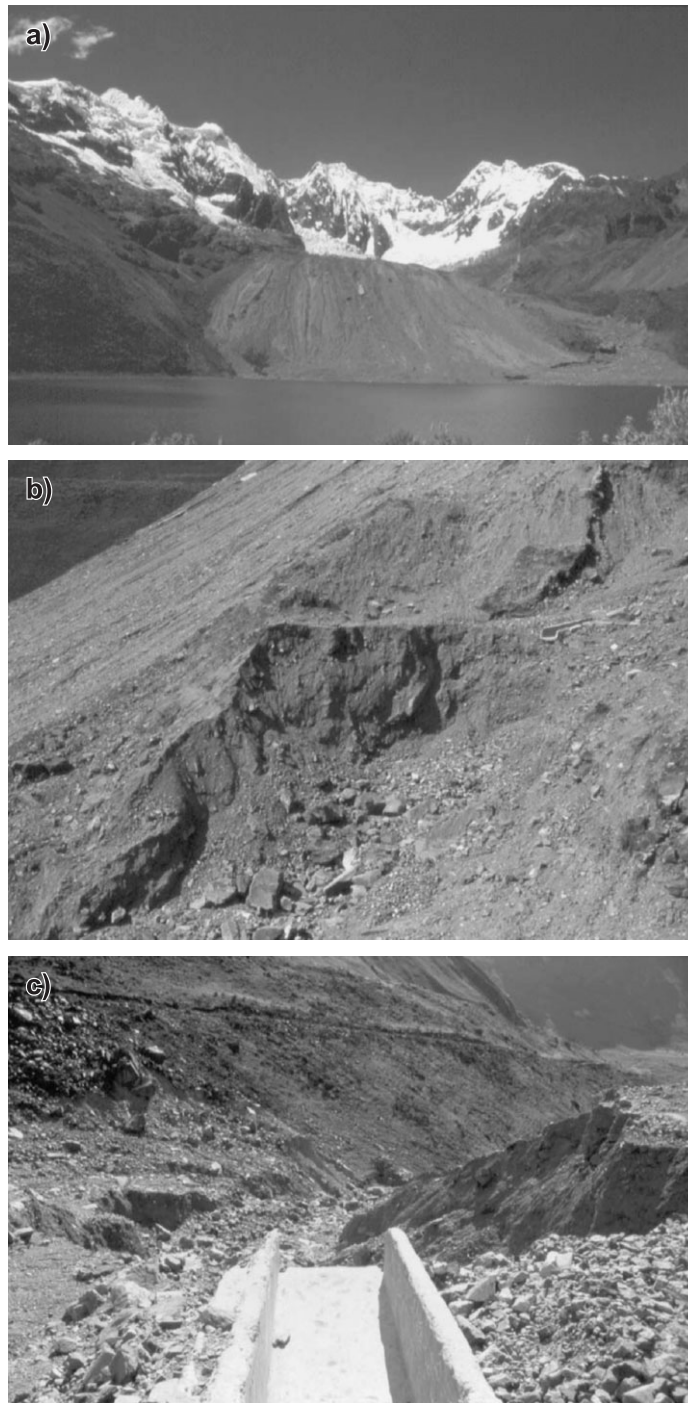
Figure 7. Photographs of the distal face of the terminal moraine dam at Laguna Safuna Alta: (a) general view (note the widespread removal of vegetation, indicated by a lighter colour, from the moraine face), (b) view of the deep gully formed below the remains of the outlet of the 1978 relief tunnel (top right) and (c) view along the end of the damaged outlet of the 1978 relief tunnel, from where an additional ~15 m long concrete spillway has been eroded.

were measured. The steeper angles are primarily associated with a deep and freshly eroded gully located below the outflow of the 1978 overflow tunnel (Figure 7(b)). This gully, which was not present in 2001, extends to the lower part of the distal face of the moraine, forming a debris fan where it enters the Laguna Safuna Baja (Figure 7(a)). The carcasses of 22 cattle, each with signs of severe physical trauma, are located on and within this debris fan. A shallower gully exists in the upper part of the distal face of the moraine dam, above the portal of the 1978 tunnel.

Even more damage was apparent to the outlet of the 1978 relief tunnel than to its inlet. At its outlet, a 15 m long concrete spillway structure was completely removed and under-cut by the deep erosion gully (Figure 7(c)). However, the interior of the tunnel appeared pristine when inspected in August 2002, containing no debris and showing no signs of interior erosion. At one location, a small fragment of the wooden formwork was observed still attached to the roof.

However, the initial wave impact appears to have injected a relatively small amount of (probably debris-poor) water through the tunnel itself. The small water volume might be explained by the protection afforded by the concrete balcony extending from the tunnel inlet (which was severely eroded by the wave) and the angle of flow of the wave past the tunnel entrance (the face is locally inclined at an angle of $\sim 50^\circ$ to the dip of the tunnel). Similarly, the erosion of the tunnel outlet is interpreted to have been achieved by the water that overtopped the moraine, initiating gully erosion along the full height of the distal face. Subsequently, the level of Laguna Safuna Alta would have been intermittently raised above the 1978 relief tunnel during the passage of the decaying seiches. Indeed, the steady-state water level after the avalanche was almost certainly temporarily raised above the tunnel entrance solely as a result of water displacement by the avalanche material deposited into the lake. During periods when the tunnel entrance was submerged by the seiche waves, water would have flowed under high pressure through the tunnel and been ejected from its outflow. This water, although initially free of debris (hence the absence of significant erosion to the inner walls of the tunnel), was responsible for extending the gully below the tunnel exit on the distal face. Indeed, close inspection of this gully indicates the presence of several nested gullies, each of which may have been formed by pressurized flow associated with the passage of a seiche (Figures 7(b) and 7(c)).

- Strategies need to be considered and implemented to reduce the risk of failure of the moraine dam at Laguna Safuna Alta. These could include strengthening the moraine dam, repairing the existing overflow channels, driving a new overflow channel through the dam or even enhancing the buffering effect of Laguna Safuna Baja by increasing its capacity.

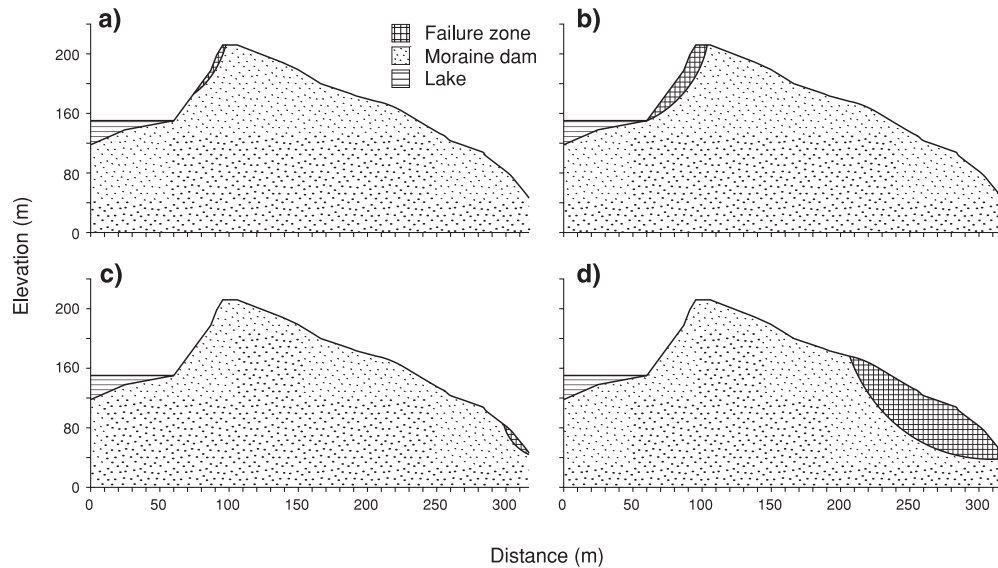
Figure 8. Calculated rotational slip surface geometries in the terminal moraine at Laguna Safuna Alta, in cross section, associated with the minimum factors of safety presented in Table I: (a) proximal face, small slip; (b) proximal face, large slip; (c) distal face, small slip; (d) distal face, large slip.

The results of the stability analysis, summarized in Table I, indicate that the most likely minimum factor of safety against a small failure on the proximal face is 0.66 (Figure 8(a)) and that against a large failure on the same face is 0.75 (Figure 8(b)). Because both values are less than unity (where a value of unity indicates that the forces maintaining the stability of the slope are equal to those destabilizing the slope) the analysis predicts that the proximal face was, in August 2002, following the avalanche and seiche, unstable to both small and large rotational failures. In contrast, the factor of safety calculated against a small failure on the distal slope is 0.94 (Figure 8(c)), while that against a major failure is 1.47 (Figure 8(d)). The former narrowly indicates instability, while the latter indicates stability.
